# USAAVLABS TECHNICAL REPORT 70-18

## SOLID LUBRICANTS FOR HELICOPTER TAIL ROTOR GEARBOXES

### Final Report

CONTRACT DAAJ02-67-C-0058  
WESTINGHOUSE ELECTRIC CORPORATION  
RESEARCH LABORATORIES  
PITTSBURGH, PENNSYLVANIA

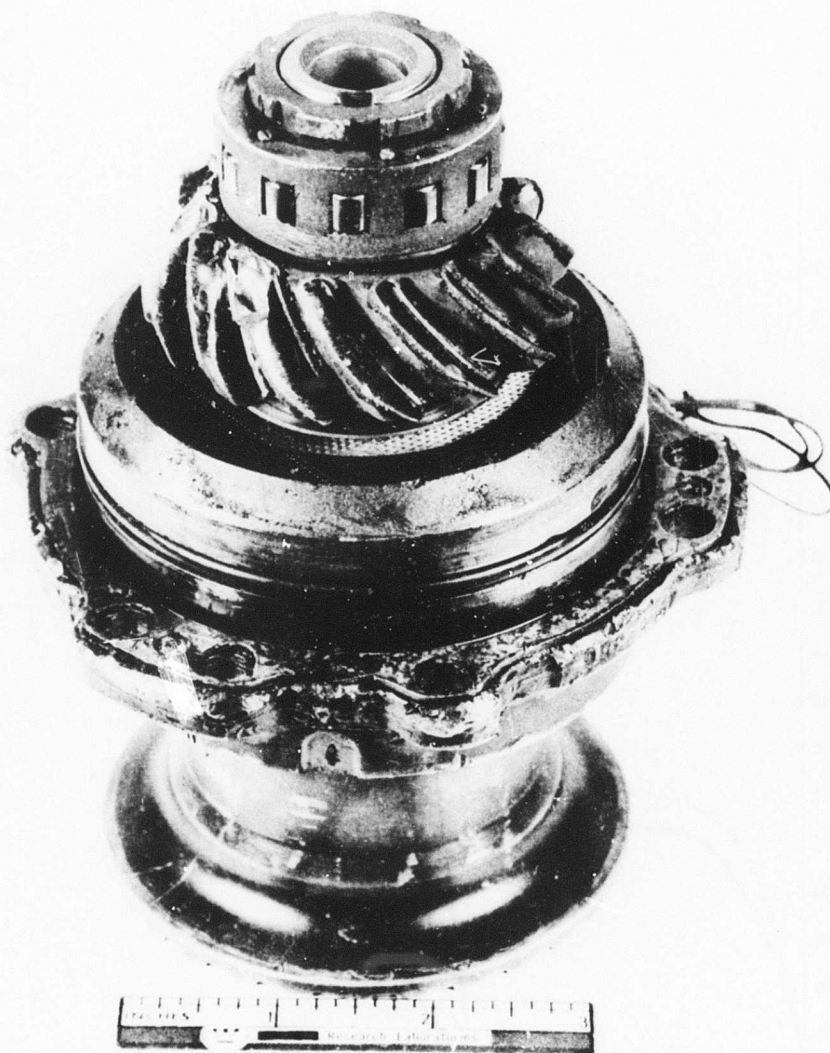
Figure 36. Pinion Assembly After Polyimide Retainer and Coated Used Idler Gear Test, Series 1A.

Both the idler gear and retainers proved to be extremely durable during the third test, as indicated in the photographs of Figures 35 through 38, when a 1/4-inch-diameter stainless steel cap screw 3/4 inch long passed through the load gear train and between the quill and idler gear. Pieces of the pinion gear and screw apparently made multiple passes through the gear train because of the number of teeth damaged on the idler gear and welding of several pieces on the quill gear. The cap screw was very similar in size, weight and hardness to a round of ball ammunition with a steel core. Little damage occurred to the idler gear (less than the damage to the pinion gear). The retainers were not damaged and survived the impact loads satisfactorily. Based on this data, the composite appeared to have excellent resistance to small-arms gunfire.
